Introduction

DataMind Al™ Identifies Significant Gearbox Deterioration

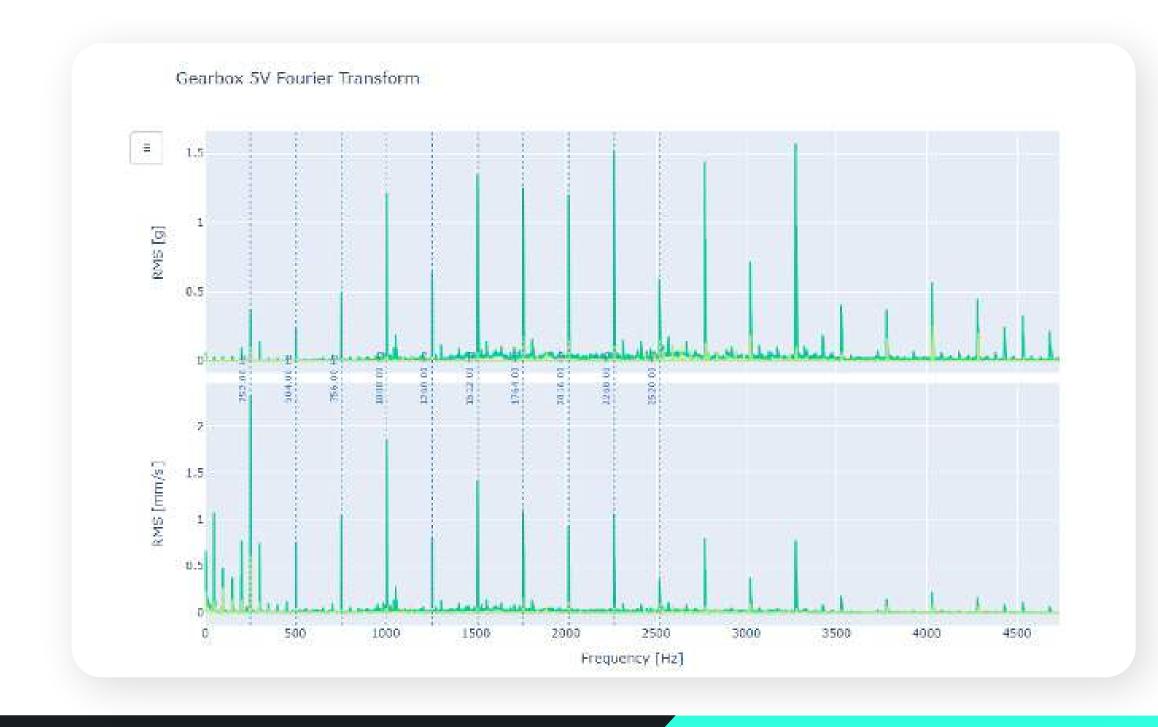
DataMind Al[™] detected increased amplitude at the gearbox output shaft running speed (252 Hz). This spectral pattern was diagnosed as "mechanical looseness in the output shaft," attributed to high workloads. The gearbox status was changed from **Healthy** to **Monitor**.

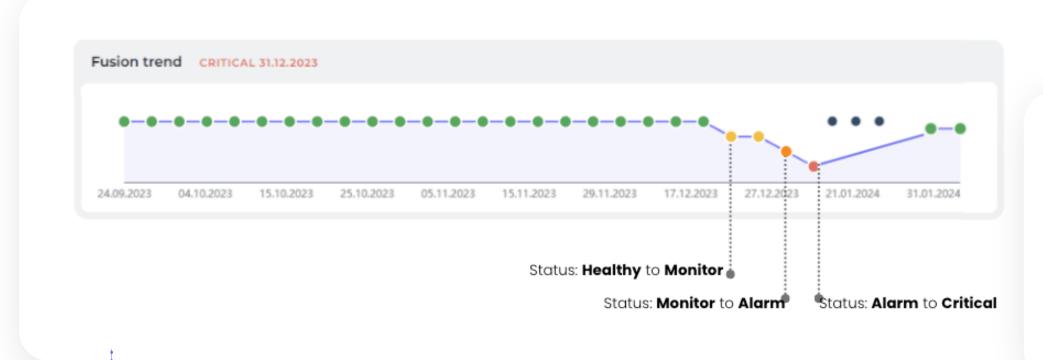
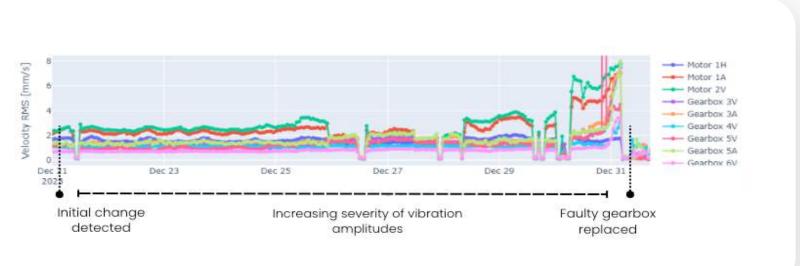
DataMind Al™ compares spectral signatures during constant machine load, using motor current as a load indicator.

In this case, it isolated times when the motor current was in the nominal range of 73-75 Amperes, confirming that the vibration signature deterioration was due to mechanical wear and not operational changes.

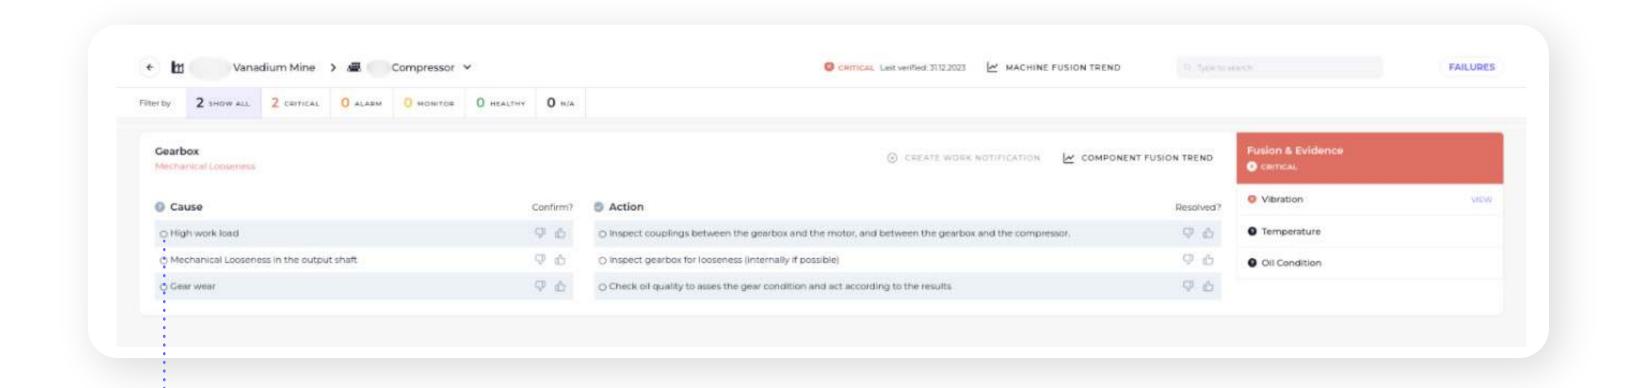
Within a week, further significant deterioration was identified; patterns present in two sensors indicated extreme vibration increases due to gear friction, high workloads, and mechanical looseness. The gearbox status was switched from **Monitor** to **Alarm**.

The customer took action to remediate the issue; however, the gearbox status further declined.

On 31 December 2023, the gearbox health status switched to Critical.

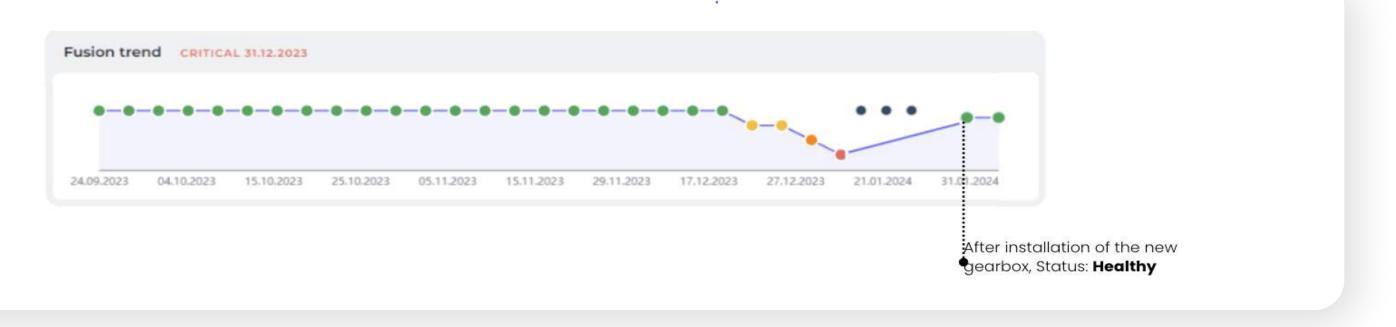
A planned 24-hour shutdown on December 31, 2023, was utilized to replace the gearbox. Following the shutdown, sensor readings indicated a return to normal activity, confirming the issue was correctly identified and resolved.
